SIMULTANEOUS EFFECTIVE REMOVAL OF POLYSULFIDE AND POLYOLEFIN FOULING FROM TWISTED TUBE® HEAT EXCHANGERS IN HYDROCRACKER PROCESS USING ULTRASONIC CHEMICAL CLEANING

ABSTRACT

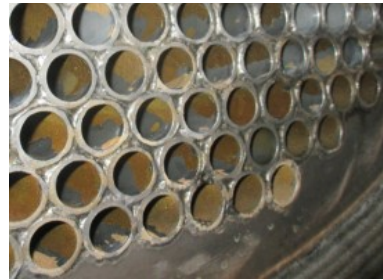
Furthermore, during a previous outage, these bundles were cleaned through a combination of chemical cleaning, delivered in place, and then removed from service for high pressure water blasting (HPWB) at a maximum pressure of 40,000 psi. The bundles were returned to service in a partially fouled condition after 14 days of hydroblast activity as the Lost Profit Opportunity (LPO) of having these exchangers out of services any longer drove the decision to put the exchangers back in service. The total downtime for the unit was 21 days, including the time to chemically clean, pull the bundles and put them back into service. Fig. 3 and Fig. 4 show that this previous attempt at cleaning was unsuccessful from a visual standpoint. The client also stated that very little improvement to the heat transfer coefficient was gained from this cleaning.

Fig. 3. Previous Cleaning Attempt. Tube Side fouling layer still observed after chemical cleaning in-place and HPWB.

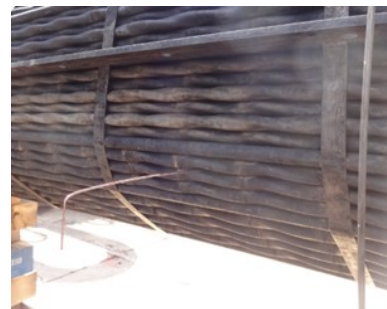
Fig. 4. Previous Cleaning Attempt. Shell Side fouling layer still observed after chemical cleaning in-place and HPWB. Debris still built up between the tubes as evidenced by the Dip Stick verification.

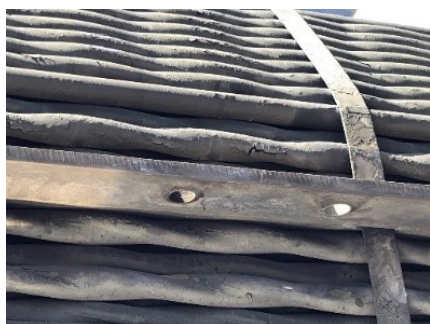
The main foulant on the shell side of the bundles, shown in Figure 5, proved to be polymeric olefin (polyolefin) compounds, and was mixed with calcium silicate, in the form of diopside ($\text{CaMgSi}_2\text{O}_6$) and CaSiO_3 , Crystalline coke particulate in the form of Graphitic Carbon (C), and iron phosphate (Fe_3PO_4) or Magnetite (Fe_3O_4). The shell side fouling has been the primary area of concern in the cleaning of these bundles.

Fig. 5. Sample Image of the Shell Side Foulant on the TWISTED TUBE® Heat Exchangers Studied Before Cleaning.

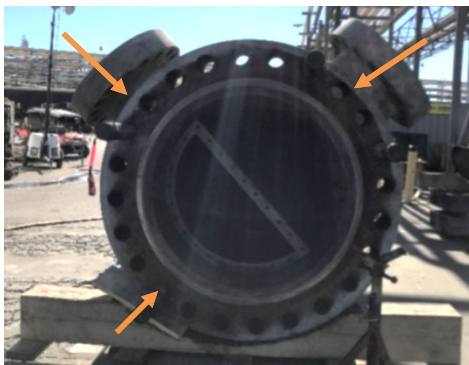
The channel heads on these heat exchanger bundles were fixed, which posed an additional challenge due to the considerations required for nozzle placement in the Ultrasonic bath. Figure 8 shows E-4 and the nozzle placement at 90°, 180° and 270° before it was placed in the Ultrasonic vessel and the accommodation for the channel head that was required to offer a 360° cleaning of the exchanger. Figure 9, shows this exchanger in the ultrasonic vessel in the initial orientation with one of the nozzles lowered into the vessel, and the final orientation.

Fig. 8. E-4 Fixed Channel head view showing the layout of the three nozzles on the head at 90°, 180°, and 270°, denoted by the orange arrows.

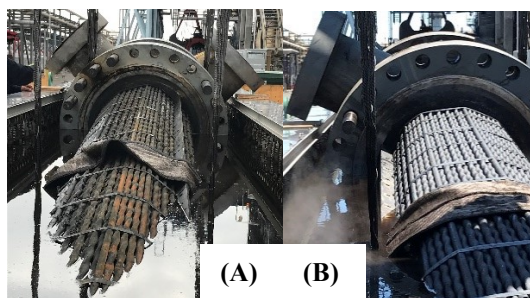
Fig. 9. E-4 accommodation in the Ultrasonic Vessel during (A) the initial immersion into the vessel and (B) the final immersion into the vessel.

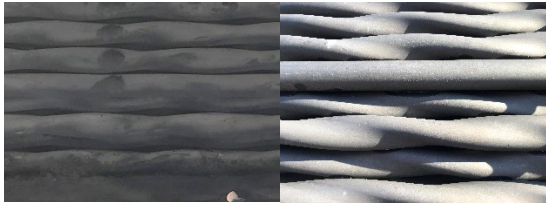
Before and after ultrasonic cleaning images are shown in figures 10 through 15 for the shell side and U-bend cleaning. Tube side cleaning was difficult to assess visually due to the fixed channel heads, but figures 16 and 17 attempt to draw the comparison, and borescope video indicated that the tube side cleaning had been successful.

Fig. 10. E-1 Before - Shell Side Close up

Fig. 11. E-1 After - Shell Side Close up

Fig. 12. E-1 Before - U-bend Close up

Fig. 13. E-1 After - U-bend Close up

After 8-10 hours of ultrasonic action, depending on the severity of the shell side fouling, the item was removed from the ultrasonic vessel and a shell side bundle blaster was used to knock off any residual shell side fouling using only 20,000 psi water pressure. The tubes were flushed with low-chloride water using a fire hose nozzle. Total hydro blast time per bundle was between 4-6 hours.

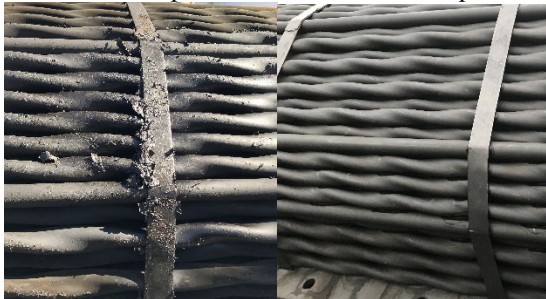
Fig. 14. E-3 Before - Shell Side Banding

Fig. 15. E-3 After - Shell Side Banding

Fig. 16. E-4 Before - Tube Side Fouling

Fig. 17. E-4 After - Tube Side Cleaning
