ULTRASONIC CLEANING OF BADLY FOULED COMPABLOC EXCHANGERS

R. Phillion^{1,2}, S. Smith², B. Kieser² and T. McCartney³

ABSTRACT

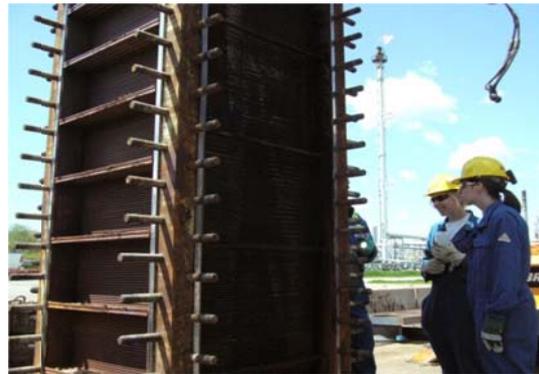
Owing to unit upsets, a significant amount of catalyst had hardened within the exchangers, forming an epoxy like substance in addition to the normal hydrocarbon fouling. A specific protocol consisting of time in the ultrasonic bath and interval rinsing with light-pressure water was developed. We anticipated that while the ultrasonic bath would sufficiently loosen foulant on the exchanger surfaces, interval water rinsing would be necessary to remove these loosened layers. This would allow the ultrasonic energy to work inward on the numerous layers of foulant in the complicated structure of the exchanger and facilitate physical displacement of the foulant. At the same time the rinsing (done externally) would reduce the loading on the cleaning fluid, which was anticipated to be heavy.

Figure 3 Alfa-Laval Compabloc Heat exchanger: CC 106A. Inspection prior to the cleaning

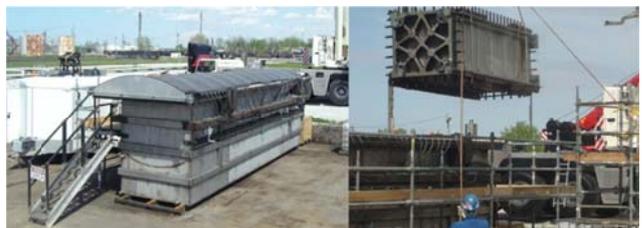
Figure 4. Covered Test Vessel

Tech Sonic utilizes a proprietary combination of ultrasonic technology and aqueous cleaning fluid within specially engineered vessels to remove both hydrocarbon and inorganic contaminants from the surface of a work piece in a rapid, safe and environmentally friendly alternative to traditional cleaning methods. A more complete description of the method may be found in (Kieser et al., 2011)

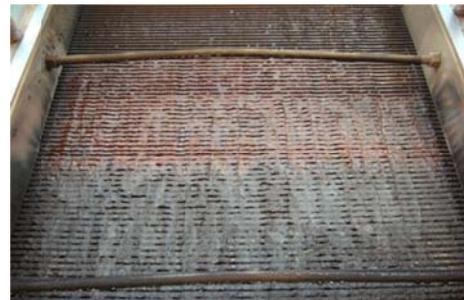
Figure 6. Close up: CC-106A --BEFORE

The first exchanger came very clean after a total of 16 hours in the ultrasonic bath and 3 hours of rinse time. When cleaning began for the second exchanger, the Refinery re-evaluated the decision to only clean two exchangers. Since the trial was considered completely successful, it was decided that all four exchangers in the top bank would be cleaned, but that all the work would have to be completed in a 2-week timeframe. Due to the time required to remove the exchangers from the unit, to disassemble and reassemble them, the timeline was very tight, and insufficient time was available to

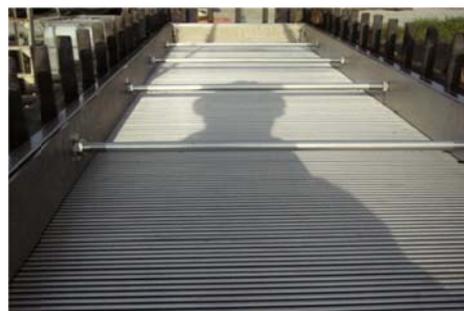
Figure 7. Close up: CC-106A --AFTER

One exchanger was cleaned to a state where detailed borescope inspection revealed no fouling and the operational DP was indistinguishable from a new exchanger. Two units, which spent less time in the cleaning vessel and had less intermediate rinsing, were visually inspected and deemed to be “close to new” condition by the Refinery. A fourth exchanger was given a quick half day treatment in the vessel and significant improvement was seen, but not enough time was available to address this unit fully. Under ideal circumstances, all four (or all 8) exchangers would be processed with the complete treatment. Figure 8 shows a
