## ALFA LAVAL EXPERIENCE WITH COATINGS TO REDUCE FOULING IN PLATE HEAT EXCHANGERS

<sup>1</sup> Materials Technology and Chemistry, Alfa Laval Lund AB, P.O. Box 74, SE-22100 Lund, Sweden

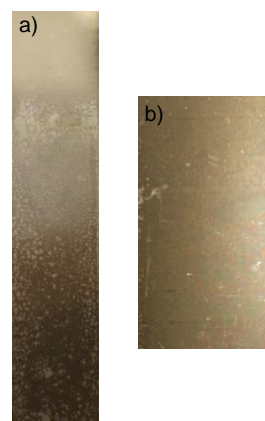
Fig. 3 Appearance of two coated coupons after being immersed in 3.5% NaCl at  $T > 60^\circ\text{C}$  for 2 weeks: a) many small blisters; b) no blisters.

The coated pieces are placed in a beaker filled with 3.5% NaCl solution at a temperature higher than  $60^\circ\text{C}$  with agitation. Fig. 3 shows two coated coupons that have been tested for 2 weeks, showing a pass and a fail sample.

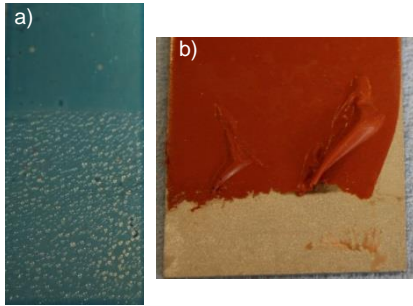
Fig. 4 Appearance of two coated coupons after being immersed in a) 5%  $\text{HNO}_3$  and b) 5%  $\text{NaOH}$  at around  $70^\circ\text{C}$  for 16 h.

Depending on the application the resistance of the coatings can be tested with different chemicals. If the plates are subjected to cleaning in place, the coatings are also tested with diverse cleaning chemicals. This is done by dipping the coated pieces in a beaker filled with the cleaning chemical solutions for a pre-defined time at a relevant temperature with agitation. Fig. 4 shows examples of coatings that failed this test.

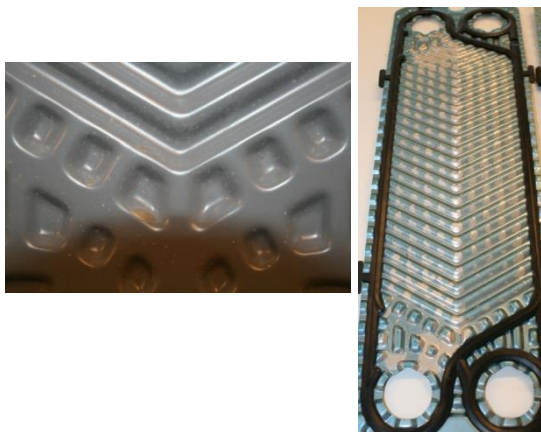
Fig. 5 Appearance of two coated M3 plates after the abrasion test: a) rating 1; b) rating 4.

To access how the different coatings tolerate abrasion from small particles present in the media an abrasion test was developed at Alfa Laval. The coated M3 plates to be tested are assembled in a heat exchanger. One side is connected to tap water and the other side is connected to the test rig and run with the abrasive media (water with 2% of solid plastic particles) at the maximum pump flow rate ( $4.8 \text{ m}^3 / \text{h}$ , average shear stress around 235 Pa) for 24h at room temperature. To achieve a higher temperature the water tap is closed and the test continued for another 24h. The coating is rated according to a classification from 0 to 4 where 0 is the best. Fig. 5 shows two coated M3 plates that have been tested for 2 days, showing different a rating of 1 – less than 10% of coated affected and a rating of 4 – more than 50% of the coating was abraded by the particles.

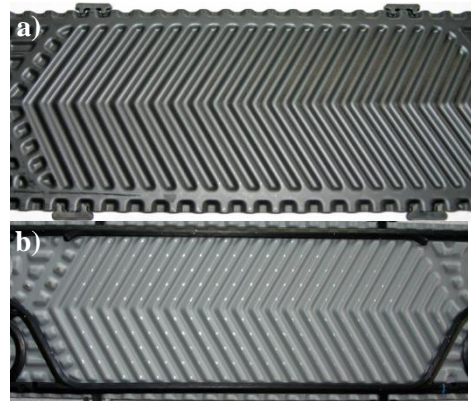
Fig. 6 Appearance of two coated M3 plates after the wear test: a) rating 0; b) rating 3

parts when the unit is in operation. To evaluate the mechanical properties of the different coatings these are subjected to a pressure fatigue test. The test is conducted according to an AL Standard Method designed to accelerate the wear and friction that plate coatings would experience in a real operational PHE. The coated M3 plates are assembled in a heat exchanger which is then connected to a pressure fatigue test rig. The test is a standard 1-phase test with a water / glycol mixture on one side and the other side filled with water and unpressurized. 100.000 pressure cycles from 2-7 bars at room temperature was chosen as test conditions (average shear stress around 235 Pa). The coating is rated according to a classification from 0 to 4 where 0 is the best. Fig. 6 shows two coated M3 plates that have been wear tested, showing different a rating of 0 – no wear at the contact points and a rating of 3 – extensive wear at the contact points.

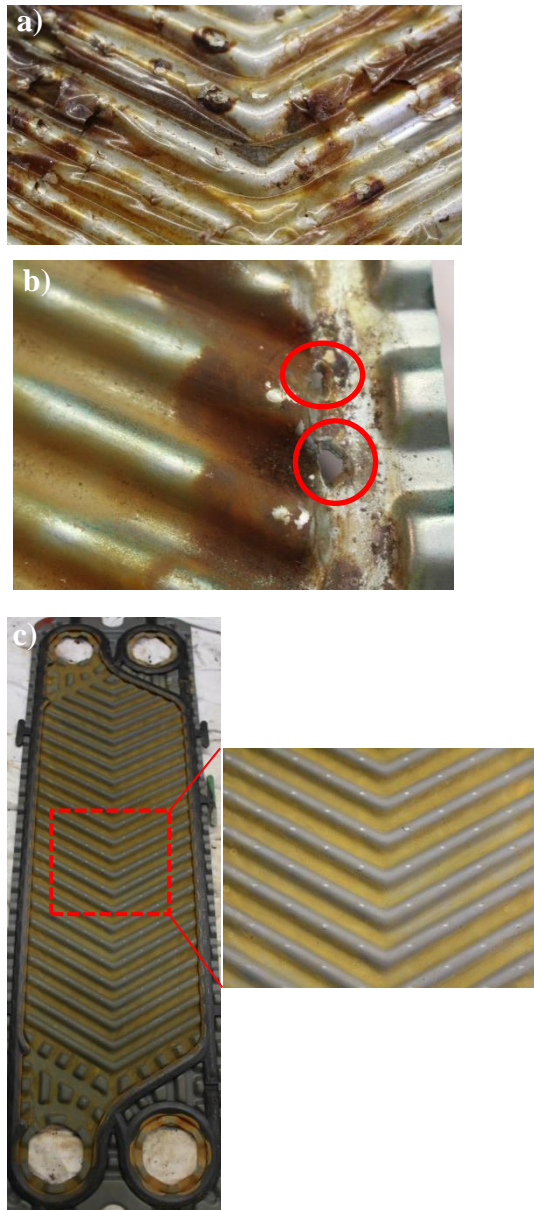
Fig. 7 Coated plates after sea water testing for: a) 6 months - coating has delaminated from the water side, b) 9 months – crevice corrosion leading to through holes and c) 27 months – no corrosion but some wear at the plate contact points.

To test the resistance of the coatings applied on plates to both water and salt water a test rig with M3 plates was developed. The M3 unit assembled with the coating plates is run for a total of 3 months at a time with around 2.4% salinity water from the North sea. The sea water enters the heat exchanger at a flow rate of around  $210 \text{ m}^3 / \text{h}$  and is heated up to higher than  $60^\circ\text{C}$  by circulating hot water on the adjacent channel. The sea water is flushed every two hours during working hours and kept idle at the same temperature during unmanned hours. Each flushing has a duration of 2 min. Some examples of coating failures and successes during the sea water test are shown in Fig. 7. In Fig. 7 a) one can see a coating, that was in contact with the tap water side, delaminating from the entire plate after a test period of 6 months. The most common corrosion type observed in PHEs in sea water is crevice corrosion due to the many crevices present in the PHE. Fig. 7 b) shows crevice corrosion, leading to

through holes, on a coated plate after 9 months in contact with sea water. Some of the coatings have showed a very good resistance to sea water. An example is shown in Fig. 7 c) where no corrosion is present after 27 months running time. The coating has however started suffering from wear at the plate to plate contact points.

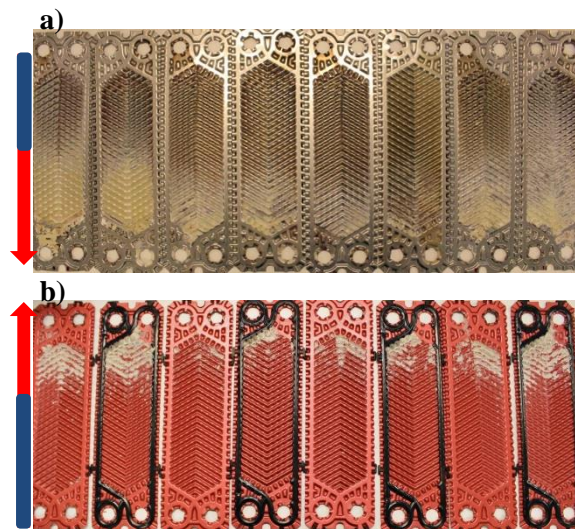
Fig. 8 Scaling on a) uncoated and b) coated plates.

in Alfa Laval Lund. Coated HE (Heat Exchanger) plates are installed in a heat exchanger unit. The test is run with a total of 10 plates. The uncoated and coated PHE units are tested in separate runs for 7 days each. Hard well water (hardness of around 26 dH) is used to generate scaling inside the HE. The hard water enters the heat exchanger at a flow rate of around 0.6 m<sup>3</sup> / h (shear stress of 25 Pa) and is heated up to 80°C by circulating steam on the adjacent channel. The PHE is running continuously for the whole test period. As seen in Fig. 8 a larger scaling amount was observed on the uncoated plates compared to the coated ones. The plates were weighted before and after the scaling test and the results are shown in Table 1. The amount of scaling on the uncoated plates was more than three times as high as compared to the one on the coated plates.

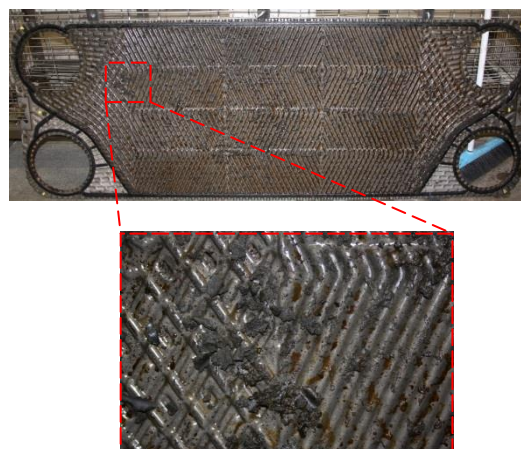
Fig. 10 Amount and appearance of the fouling on a coated plate (fully coated, after 5 months operation).

The next step was to field test two PHE's consisting of a fully coated plate pack. One of the heat exchangers was in operation for 5 months before being disassembled and the coating performance investigated. The second heat exchanger was in operation for 3 years. Fig. 10 shows that the amount of fouling on the coated plates was minimal. The adhesion of the fouling layer to the plates was also very weak where after cleaning with a dry cloth almost no fouling remained (Fig. 11).

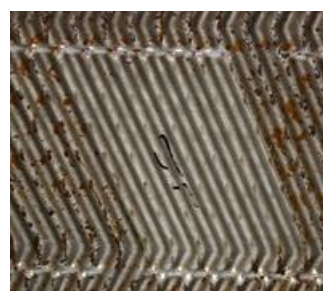
Fig. 11 Area of a coated plate cleaned with a dry cloth showing that the easy to clean and repellent properties of the coating remained intact after 5 months in operation.

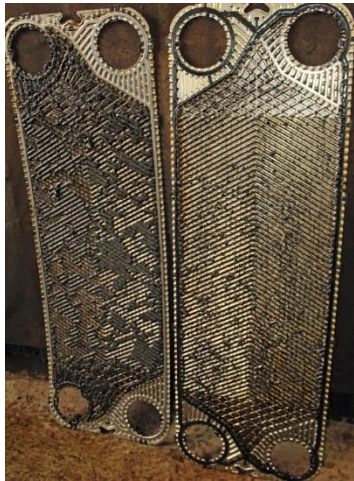
Fig. 12 Amount of fouling on the: a) uncoated and b) coated plates.

In this application the coating was applied on 64 M15 plates in stainless steel alloy 316, out of 370 plates. The heat exchanger was in operation for 5 months. Lower amounts of fouling were seen on the coated plates as compared to the uncoated plates (Fig. 12). To visualize the condition of the coating after the test, a cloth was used to clean part of the plate. The appearance of the coating is seen in Fig. 13 where no delamination or blisters were observed.

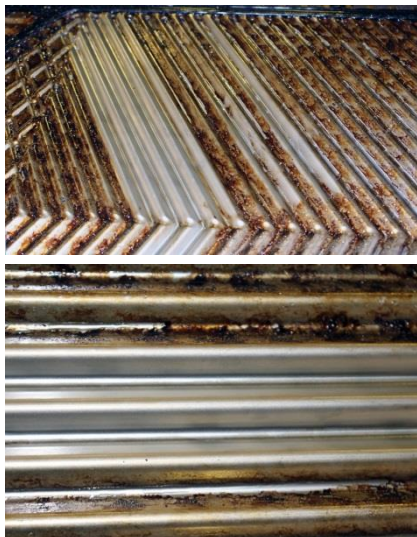
Fig. 13 Appearance of the coating after rubbing with a cloth. No coating delamination or blisters were observed.

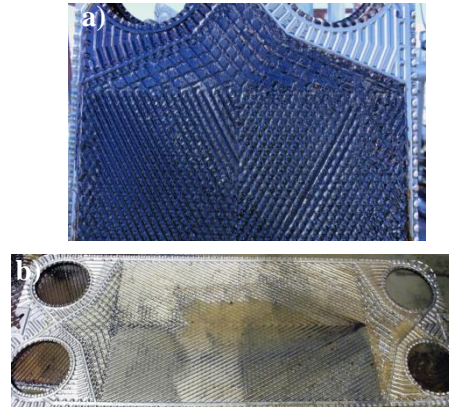
Fig. 14 a) Appearance of the fouling on coated plate; b) coated plate after high pressure water jet cleaning.

The fouling layer was partly removed by a high pressure water jet (Fig. 14). After the test the coating was still in a good condition, no blisters or delamination was observed. The easy to clean

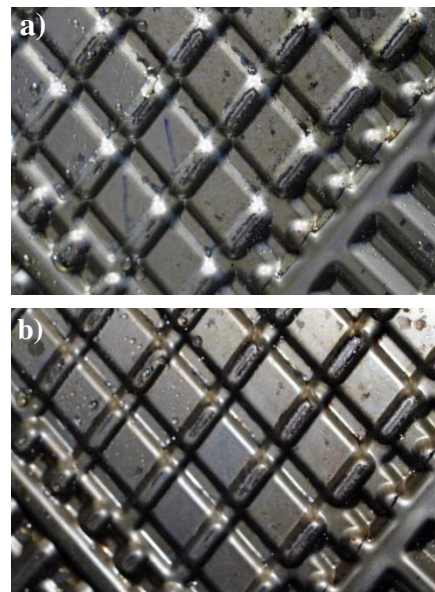
Fig. 15 Pen test on the coated plate: a) No beading effect, b) easy to clean effect.

effect was still present on parts of the coated plates (Fig. 15).

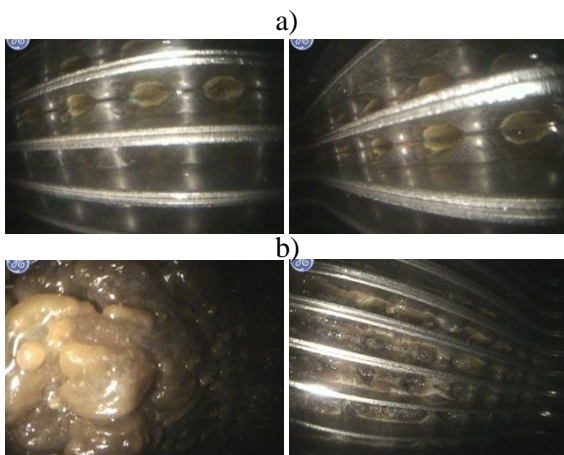
Fig. 16 Appearance of the channels near the tap water side ports. Tap water a) inlet and b) outlet.

the uncoated unit is seen in Fig. 16 from the tap water inlet and outlet. On the inlet of the tap water side no scaling was present as expected since the temperature is low (Fig. 16a). On the outlet a huge amount of scaling was present (Fig. 16b). The corresponding pictures on the coated CB are shown in Fig. 17 where as seen very little scaling was present on both tap water inlet and outlet.

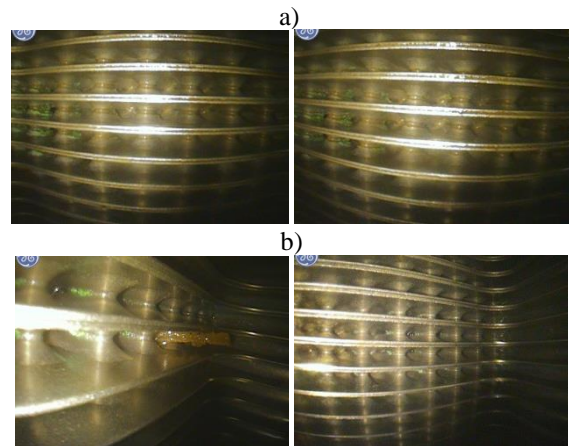
Fig. 17 Appearance of the channels near the tap water side. Tap water a) inlet and b) outlet.

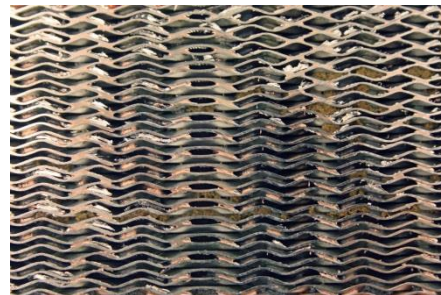
Fig. 18 Appearance of the channels on the tap water outlet side.

The units were cut open and the channels imaged with a stereo microscope. On the uncoated CB many of its channels were blocked with scaling which is in line with the thermal analysis results (Fig. 18). On the coated CB unit no scaling was present on the channels near the tap water inlet (Fig. 19 a) and little or no scaling on the channels close to the tap water outlet (Fig. 19b).

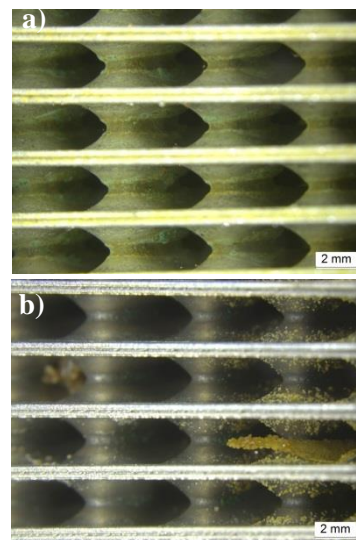
Fig. 19 Appearance of the channels on the tap water side. Close to the: a) inlet and b) outlet.
