## THE USE OF COMPARATIVE MODELLING OF HEAT EXCHANGERS IN COOLING WATER TO AVOID UNSCHEDULED PRODUCTION DOWNTIME

E.S. Beardwood

Solenis LLC, 3 Beaver Valley Road, Suite 500, Wilmington, DE, 1980, USA, [tbeardwood@solenis.com](mailto:tbeardwood@solenis.com)

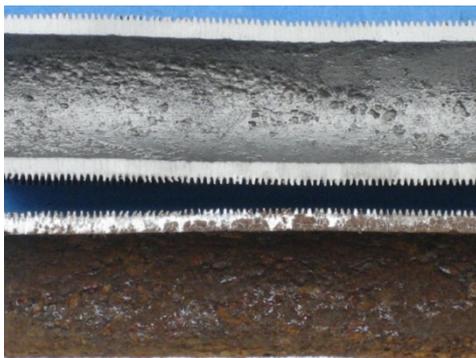
Fig. 1

Heat Exchanger 9A Tube Sectioned Tube, Cleaned Section, pitted surface. Un-cleaned Section; Note ID tube wall to deposit interface - very little deposition. Wall measurement was 0.10 – 0.106 inches and pit depth varied from 0.016 to 0.022 inches

The audit finished with a tube removal from heat exchanger 9A bundle for inspection. It had been in service from new for two years and, after the first six months of service, it received direct effluent water from the 9B heat

exchanger that was leaking light, hydrocarbon-containing hydrogen sulfide for four months. Only water jetting of the 9B heat exchanger was performed after the leaking tube was plugged. Heat exchanger 9A operated another four months prior to receiving cooling water in which heat exchanger 8A was undergoing process leakage for another six months prior to the outage. The surface contained very little deposition. Top coating of the deposit was from the corroded iron produced during the six month inleakage of exchanger 8A (Figure 1) and the concurrent reduced cooling water flow discussed previously. Upon mechanically cleaning to the bare surface, pits were noted but inactive as their bases were black and passive. The wall loss associated with the pits ranged from 16 to 21%. This was initiated by exchanger 9B process leak after the first six months of operation of exchanger 9A and occurred over a four month period, resulting in localized wall penetration or corrosion rates of 48-67 mpy (i.e., (inches of penetration x 1,000 x 365 days) / days of penetration duration). The occurrence was prior to leak contingency provided in 2008; however, it re-passivated on-line as can be seen in Figure 2. No sulfur or sulfates were found in the composite surface deposit provided in Table 7.

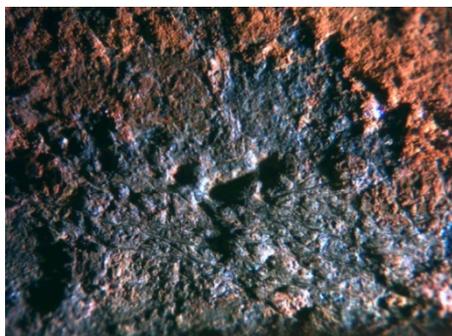
Fig. 2

Heat Exchanger 9A Tube at 10x Magnification, Mechanically Cleaned to Bare Surface

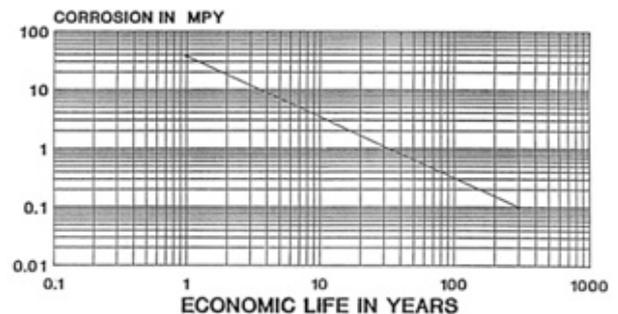
Fig. 3

General Corrosion vs. Equipment Life Schedule 40 Carbon Steel

What was the life cycle cost of heat exchanger 9A from the localized corrosion? Economic life can be estimated by using Figure 3. The 3/4 inch heat exchanger tube had a wall thickness of 0.106 inches, while an equivalent 3/4 inch schedule 40 carbon steel tube has a wall thickness of 0.1556 inches. Correcting for wall thickness differences and using the localized corrosion rate, the life expectancy would be 3.9 to 4.9 months or 2.5 to 3.0 tube failures per year. Now if we assume re-passivation, as it did; and that a continuous leak is present from another heat exchanger in the system but not in tandem series, then 1.5 mpy or a 17 year life span is then reduced to 13.5 years based on the initial localized wall loss of 0.022 inches. This is illustrated in Table 8. Hence, the longer the leak occurs and is discharged directly into the tandem heat exchanger, localized corrosion will ensue. The in tandem series receiving heat exchanger would be expected to fail in four months. However, if the leak is caught and killed, on the run, with the correct contingency plan, expect 21% depreciation or a reduction in tube life from 17 to 13.5 years. This depreciative loss on exchanger tube life, or let us say all tubes are affected, so exchanger bundle life has to be compared to uninterrupted production throughput profits and the cost of a forced outage with no production or reduced production.
