## COATINGS TO REDUCE FOULING IN PLATE HEAT EXCHANGERS: TWO CASE STUDIES

**Olga Santos<sup>1</sup>, Yves Adriaenssens<sup>2</sup>, Clemens Victor<sup>3</sup>, Magnus Nilsson<sup>3</sup>**

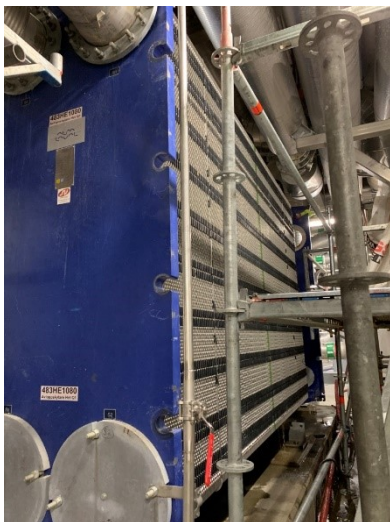
Fig. 1 - The WG350 GPHE (HE1080) with the coated plates at the customer site.

One of the WG350 PHE (HE1) installed at the paper industry can be seen in Fig. 1. The HE2 had already been opened (on the day before the inspection) and the coated plates were set aside for inspection (Fig. 2). Of the 5 installed coated plates, 2 were coated with the 3-layers PFA and 3 with the 2-layers FEP coating (darker green). The temperature of the process side on this HE goes from 50°C to 34°C and therefore the scaling is less problematic compared to the HE1. The coated plates were placed at the back (20 plates from the pressure plate) of the plate pack. It was seen that the coated plates were covered with fouling which consists of calcium oxalate and fibers (Figs. 3 and 4).

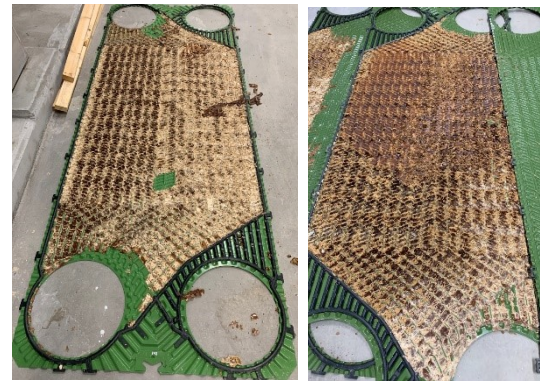
Fig. 3 - Fouling on the 3-layer coating (left) and 2-layer coating (right).

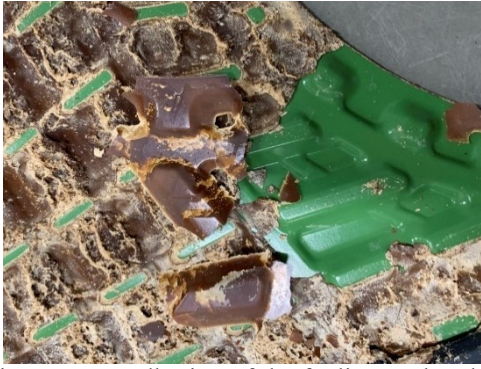
Fig. 5 - Low adhesion of the fouling to the plate. It can be removed easily with the finger.

The scaling adhered loosely on all coated plates and was displaced with no force required (Fig. 5). On the 2-layer coated plates one can see that a big part of the scaling from one plate was collected on the adjacent plate when these were separated (Fig. 6). The plates were partially cleaned with high water pressure jet and the scaling is easily removed from the plates (Fig. 7). No delamination was seen on the coated plates but some small blisters were present on the 3-layer coated plates (Fig. 8). This was seen all

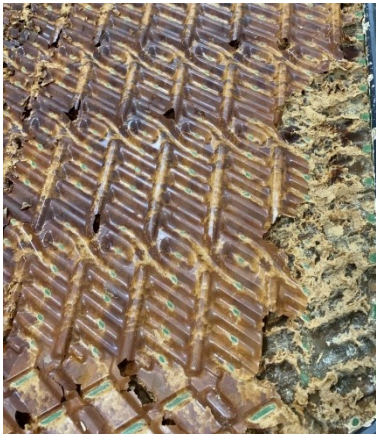
Fig. 6 - The fouling layer from one coated plate was collected on the adjacent coated plate when the plates were separated.

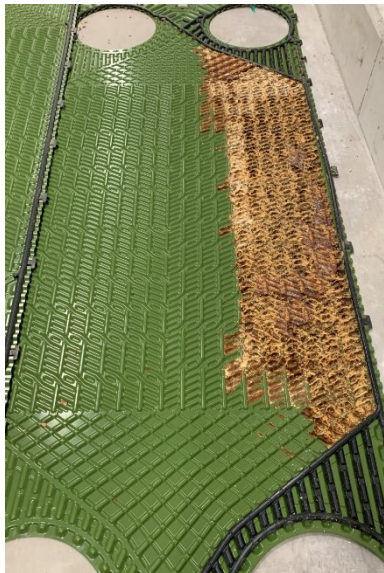
Fig. 7 - Coated plate that was partly cleaned with high water pressure jet. The fouling layer was removed very easily.

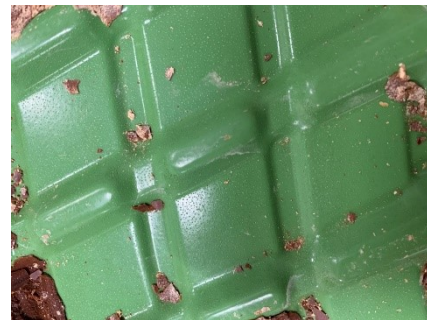
Fig. 8 – Blisters on the 3-layer coating.

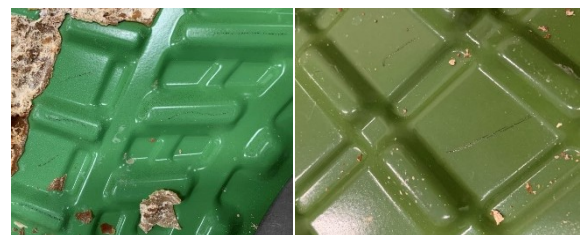
Fig. 10 – Repellency on the 3 and 2-layer coatings after the field test.

over the plate (no dependency on the temperature). On the 2-layer coating these small blisters were seen only on limited areas of the plate (Fig. 9). All coated plates still showed repellency and easy to clean effect all over the plate (Fig. 10).

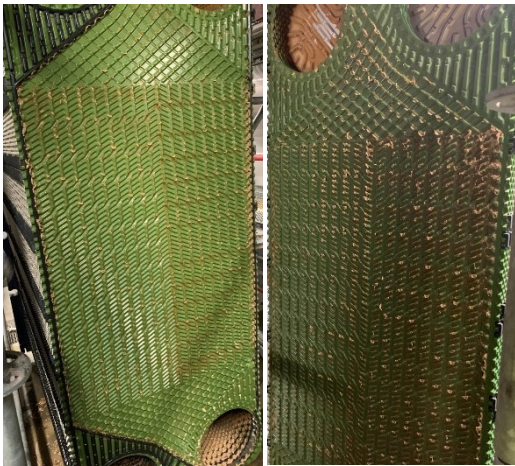
Fig. 12 – Fouling on the 2-layer coated channel.

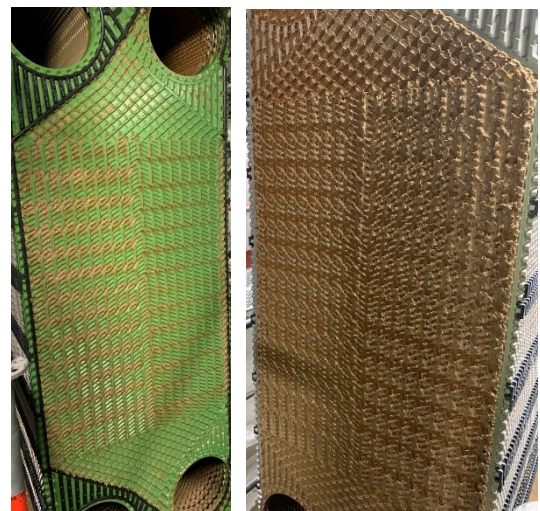
Fig. 14 – Fouling on a channel formed by a coated (3-layer) plate and an uncoated plate.

plates with 3-layer coating) were installed in the middle of the HE. The amount of fouling on the uncoated plates was substantial consisting of a very thick layer of soft material (Fig. 11). The calcium oxalate scale builds up on the plates creating a rough surface where the flowing fibers can easily attach. The amount of fibers in the process water is 50 ppm according to the customer. On the coated plates almost no fouling was present (Figs. 12 and 13). The difference in amount of fouling between uncoated and coated plates was tremendous as can be seen on previous figures and on Fig. 14 where the channel was formed by an uncoated and coated plate.

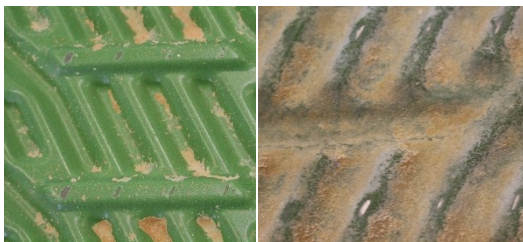
Fig. 16 – Wear at the plate-to-plate contact points on the 3- (left) and 2-layer coating (right).

side. This was seen for both coatings (Figs. 17 and 18). To assess the coating condition a pen marker test was performed. The 3-layer coating kept some of its repellency and easy to clean effect as seen by the beading effect of the marker ink (Fig. 19) and the total removal of the ink with a dry tissue. On the other hand, the 2-layer coating showed no repellency on the process water side (Fig. 19) and a decrease in the easy clean effect.

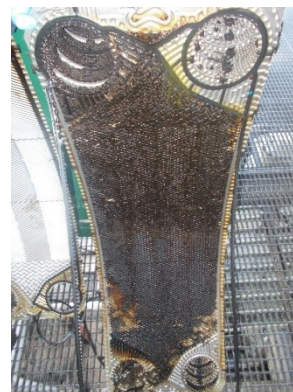
Fig. 18 – Fouling on the uncoated plate.

The fouling appearance on an uncoated plate is shown in Fig. 18 (picture provided by the customer). Evaluation of the coatings was performed at the R&D Alfa Laval in Lund. The coated plates have been in operation for a total of 24 weeks. The plates coated with coating 1 were found to be covered with fouling (Fig. 19). The fouling adhered strongly to the plate and it was not possible to clean with a tissue. The pen test showed no repellency and no easy to clean effect (Fig. 20). On the plates coated

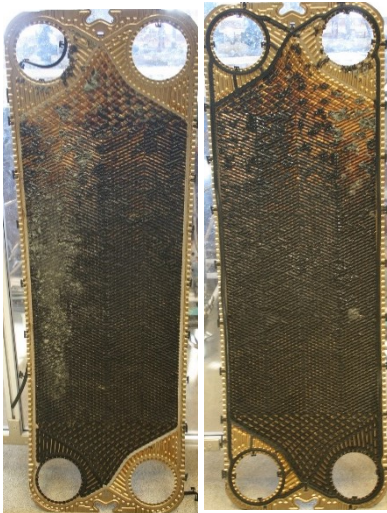
Fig. 19 – Fouling on the plates with coating 1.

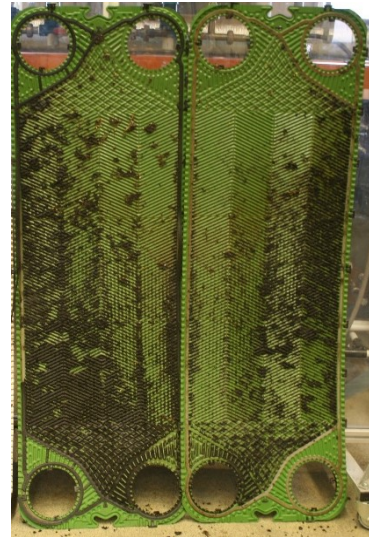
Fig. 23 – Fouling on the 2-layer coating.

with coating 2 less fouling was seen compared to the uncoated (compare Fig. 18 with 21) and the adhesion of the fouling was also lower on this coating. The pen test showed no repellency but easy to clean effect (Fig. 22). The lowest amount of fouling was seen on the Chemours coated plates (Figs. 23 and 24). The 3-layer coating had a slightly lower amount of fouling compared to the 2-layer coating. The adhesion of the fouling on both coatings was also low making it easy to remove the deposit with a tissue. The pen test showed both repellency and easy to clean effect (Fig. 25).

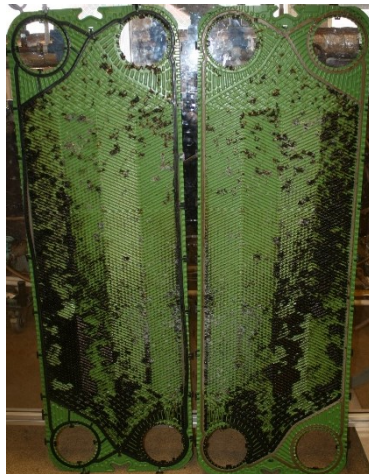
Fig. 24 – Fouling on the 3-layer coating.

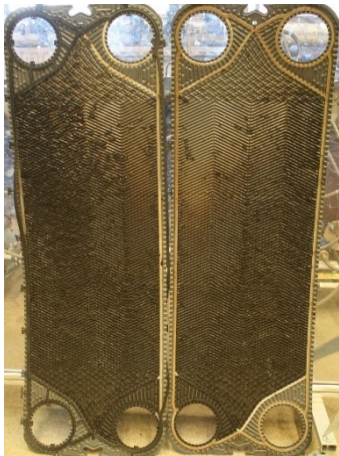
Fig. 21 - Fouling on the plates with coating 2 and the uncoated end plate.

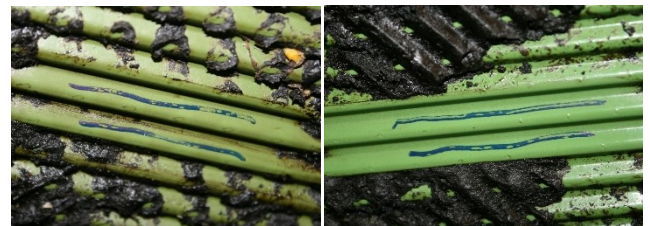
Fig. 25 – Repellency on the 2- and 3-layer coating.
