SIMULTANEOUS EFFECTIVE REMOVAL OF POLYSULFIDE AND POLYOLEFIN FOULING FROM TWISTED TUBE® HEAT EXCHANGERS IN HYDROCRACKER PROCESS USING ULTRASONIC CHEMICAL CLEANING

ABSTRACT

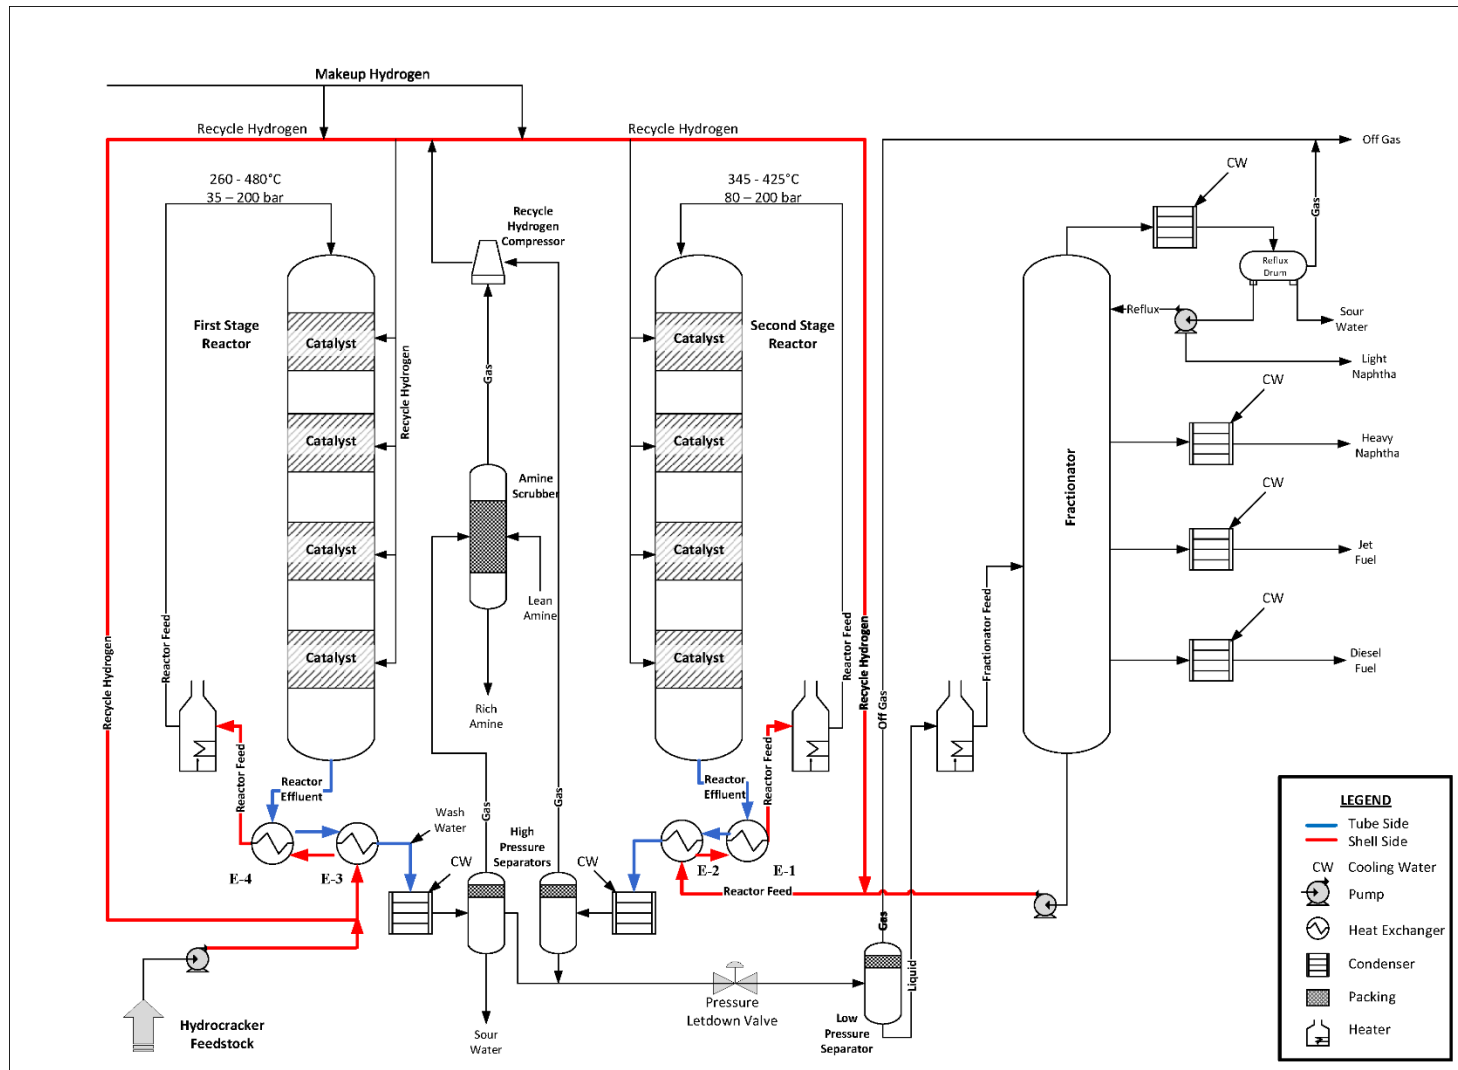
Fig. 18. Hydrocracker Process. Heat exchangers E-1 & E-2 are located below the Second Stage Reactor. Heat exchangers E-3 & E-4 are located below the First Stage Reactor. The tube side process fluid is the reactor effluent (blue); whereas, the shell side process fluid is the reactor feed (red).
