EXPERIMENTAL STUDY OF THE EFFECT OF HYDROCARBON CONDENSATION ON THE FOULING DEPOSITS OF EXHAUST GAS RECIRCULATION COOLERS

Paz C.*, Concheiro M., Vence J. and Cabarcos A.

*Author for correspondence School of Industrial Engineering, University of Vigo, Vigo, CP. 36310, Spain, E-mail: cpaz@uvigo.es

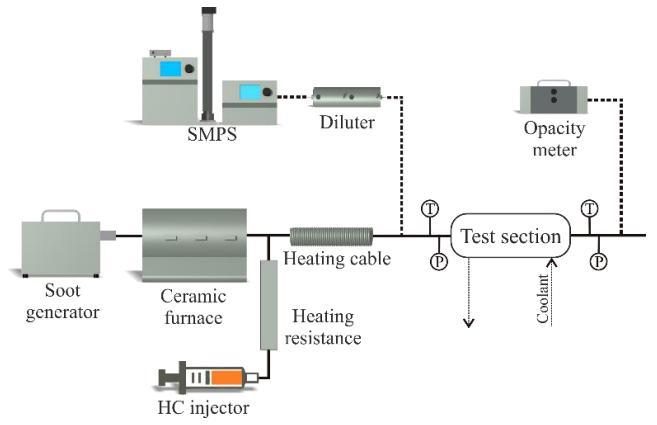
The experimental test bench used in this study has been designed to reproduce the fouling phenomenon under controlled conditions and some of its important elements have been presented in detail in previous studies [16, 17]. Figure 1 depicts the scheme of the test facilities, where the soot generator, the heating zone, the hydrocarbon injector, the test section, the

diluter, the scanning mobility particle sizer (SMPS) and the opacity meter are the main parts.

Fig. 1. Scheme of the fouling test bench.

The MiniCAST 5203 Type C soot generator, that provides particles in the range of 20-200nm (mean mobility diameter) and particle concentrations up to 108 part/cm³, generates the exhaust gas flow with a maximum flow rate of 200L/min. Downstream the soot generator, the heating zone, which is made up of a ceramic furnace and a heating cable, has been installed to heat the exhaust gas to reach the working temperature of EGR systems (200-800°C).

In order to study the fouling process under high hydrocarbon concentration, the Syringe pump NE-500 system has been added to the test bench. This dispensing system allows to inject hydrocarbon into the exhaust gas line with a volume flow in the range 0.73μ L/h-2120mL/h. In order to ensure that all the injected hydrocarbon is vaporized, a heating resistance has been added downstream the hydrocarbon injector.

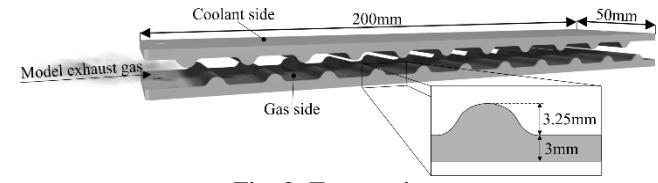
In order to inspect the final fouling layer appearance, a device with removable parts has been selected. The test section is made up of two ribbed plates that are mounted in a coolant housing creating a rectangular channel with a hydraulic diameter of 13.97mm through which exhaust gas flows (Figure 2). The plates, that have been designed to create non-uniform gas flows, allows to examine the fouling deposit that grows over the different regions of the rib-roughened surface.

Fig. 2. Test section.

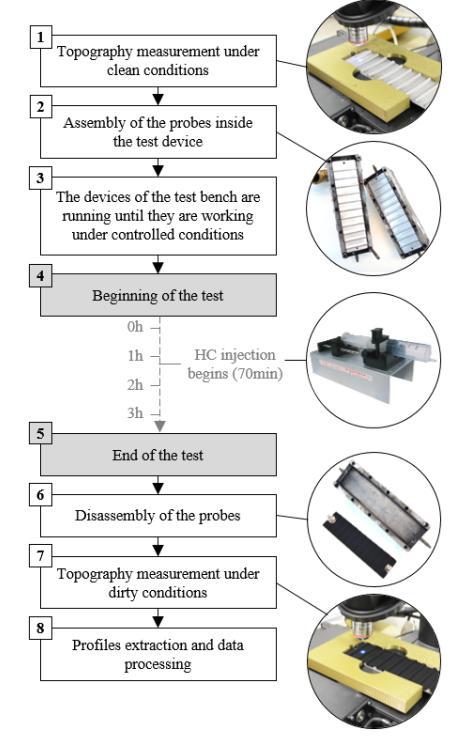
The test plates have been tested following an eight-steps methodology, as Figure 3 illustrates. Before starting the test, the plates are scanned using the optical profiler to acquire the topography of the plate under clean conditions. After that, the couple of ribbed plate are assembled inside the test device. The soot generator, the heating zone and the coolant circuit are running until they are working under controlled conditions, and when operating conditions are reached, the gas line is opened and the test begins. During the test, the gas temperatures and pressure drop inside the test section are monitored. Moreover, using the SMPS, the particulate matter distribution is measured upstream the test section. After the first 70 minutes of the test, the syringe pump is activated and the hydrocarbon injection begins. After three hours, the test ends and the ribbed plates are disassembled from the heat exchanger. The topography of the fouled plates is measured and the fouling layer profiles are extracted.

Fig. 3. Test methodology

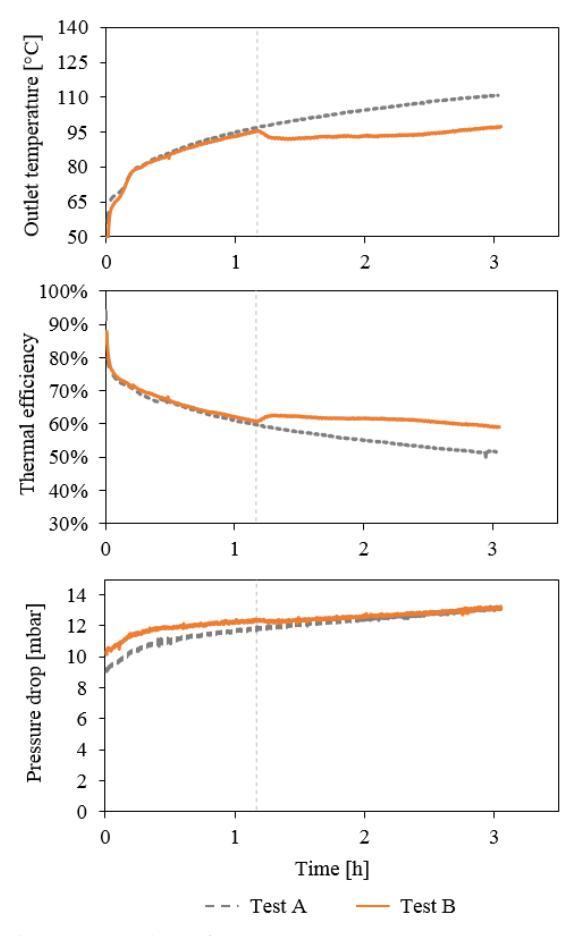
Fig. 4. Evolution of the outlet gas temperature, thermal efficiency and pressure drop along the test section. Dashed vertical line represents the beginning of HC injection (70min).

The injection of a high concentration of hexadecane in the exhaust gas causes the drop of the outlet gas temperature, as Figure 4 shows. Although the evolution of the outlet gas temperature in both cases is similar during the first 70 minutes, immediately after beginning hydrocarbon injection, the outlet gas temperature of test B falls from 95.1°C to 92.2°C. At the end of the test, the difference in the outlet gas temperature between both test is 13.4°C. This effect, that has been also detected in the evolution of thermal efficiency, could be caused by two factors: the increase of the thermal conductivity of the deposit due to the diffusion of the hydrocarbon condensate in the fouling layer; and the fragmentation and removal of some deposit areas encouraged by the accumulation of large amounts of condensate.

On the one hand, the hydrocarbon condensate changes the fouling layer nanostructure collapsing the porous of the deposit, increasing its density and hence its thermal conductivity [6, 8, 18–20]. This increase in thermal conductivity, improves the thermal efficiency of the heat exchanger, reducing the outlet gas temperature, as Figure 4 illustrates.

In both tests, the evolution of the pressure drop along the test section is similar and significant differences have not been observed. Since this is a device with a larger hydraulic diameter (13.97mm), in both cases the growth of the fouling layer does not cause a large increase in the pressure drop.

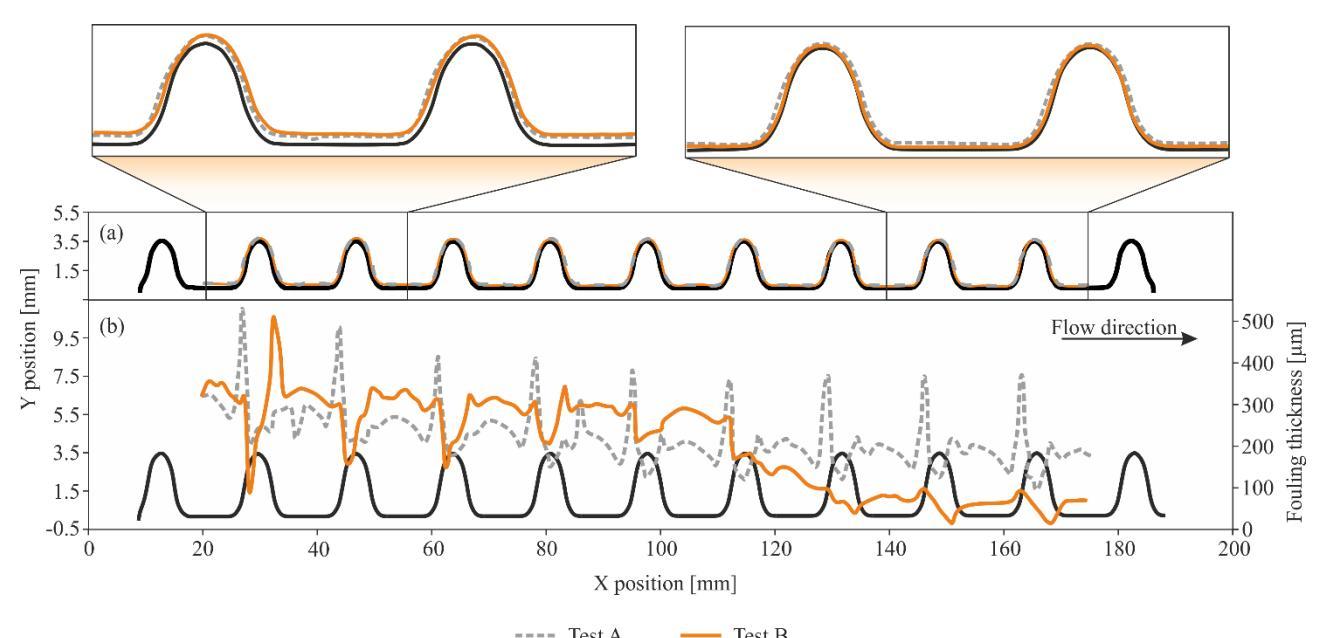
Analyzing the deposit thickness at the end of the test in a local manner, it has been observed that the deposit exposed to hydrocarbon condensation —test B— shows two differentiated parts, as Figure 5 shows. The first half of the plate —where the thickness of the deposit is higher than the test A— and the second half of the plate —where the fouling thickness is abruptly reduced—. The average fouling thickness of the test A ranges from 252.8µm in the inlet region to 187.1µm in the outlet region, while in the test B, the average fouling thickness ranges from 292.0µm in the inlet region to 74.3µm in the outlet region, as Table 2 reports.

Fig. 5. Deposit profiles (a) and fouling layer thickness (b) at the end of the test.

fouling layer in the first half of the plate. In this region, the deposition of the particulate matter, formed by the combination of soot particles and condensed hydrocarbons, is driven by the thermophoretic effect causing thicker deposits than ones caused by dry soot particles —test A— [22]. Likewise, the hydrocarbon condensation increases the particle sticking probability giving rise to a larger amount of deposited particles on the first half of the plate. Moreover, it has been detected that the reduction of the rolling of particulate matter over the deposit due to the presence of hydrocarbon in the deposit, reduces the fouling layer thickness in the particle accumulation areas, such as the foot of the ribs, as Figure 5 shows.

The abruptly reduction of the thickness of the deposit in the second half of the plate could be caused by the large amount of condensate that appears on the regions where the fouling layer is thinner. The lower gas temperature and slower increase in the surface temperature of the deposit encourage the hydrocarbon condensation in the outlet region [23],[24]. In this area, the accumulation of large amount of condensate could wash-out the particles of the deposit causing the reduction of the thickness of the fouling layer. As Figure 6 illustrates, the mud cracks that appear on the fouling surface reveal that the volatilization of the condensed hydrocarbons causes the degradation of the fouling layer and changes its physical structure [22]. As Lance et al. [7] have reported, the mud cracks are formed as the muddy deposit dries and contracts providing a fractured deposit. Compared with the smooth appearance of the sections of the inlet region, the sections analyzed in the outlet region show a cracked appearance with more grooves as it moves towards the end of the plate. This effect may be the origin of the spontaneous regeneration that has been registered in the thermal efficiency evolution and that has been reported by various EGR manufacturers [7].

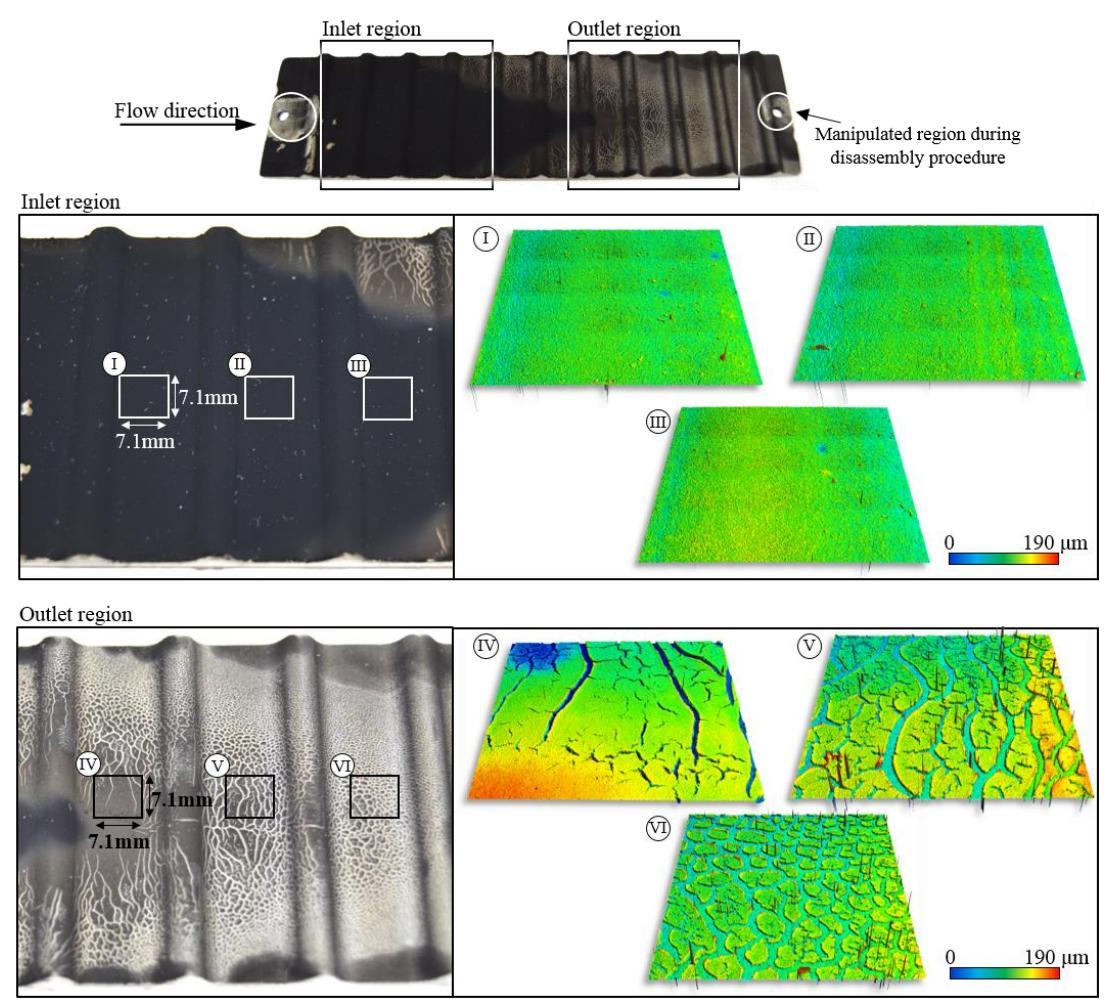
Fig. 6. Final appearance of fouling deposit of test B and details of the topographies of the fouling layer.

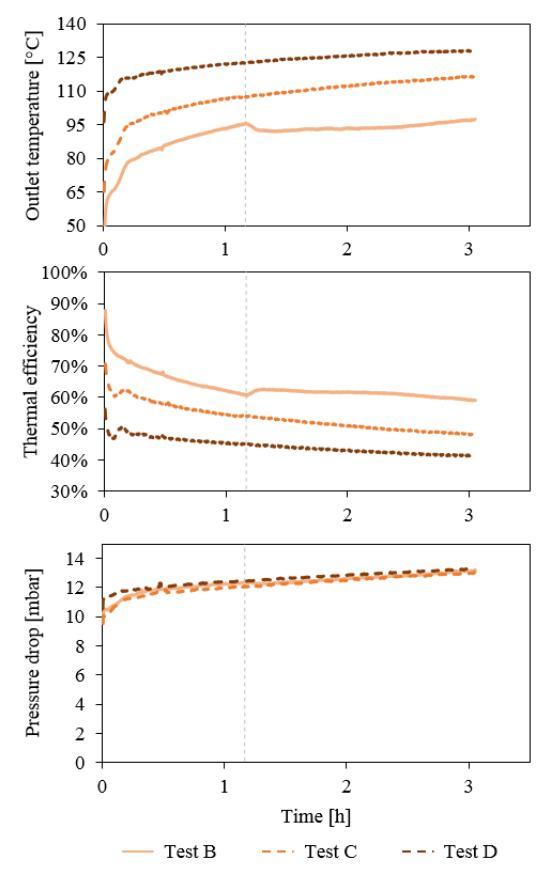
Fig. 7. Evolution of the outlet gas temperature, thermal efficiency and pressure drop along the test section. Dashed vertical line represents the beginning of HC injection (70min).

As would be expected, the evolution of the outlet gas temperature shows that the lower the coolant temperature, the lower the outlet gas temperature, as shown in Figure 7. It has been noted that only the test B -with the lowest coolant temperature- shows a change in trend when hexadecane injection begins. In the same manner, the graph of the evolution of the thermal efficiency, which also registers this effect, exhibits an increase of 2% 6 minutes after the beginning of the HC injection. On the contrary, the evolution of the outlet gas temperature and the thermal efficiency of the tests C and D have not been affected by the presence of hexadecane in the exhaust gas flow. Since for the selected hydrocarbon injection flow (100µL/min) the hexadecane dew temperature is 61.5°C, hydrocarbon condensation does not occur in tests C and D and, in these test, the amount of hydrocarbon in the fouling layer is not large enough to change the structure of the deposit.

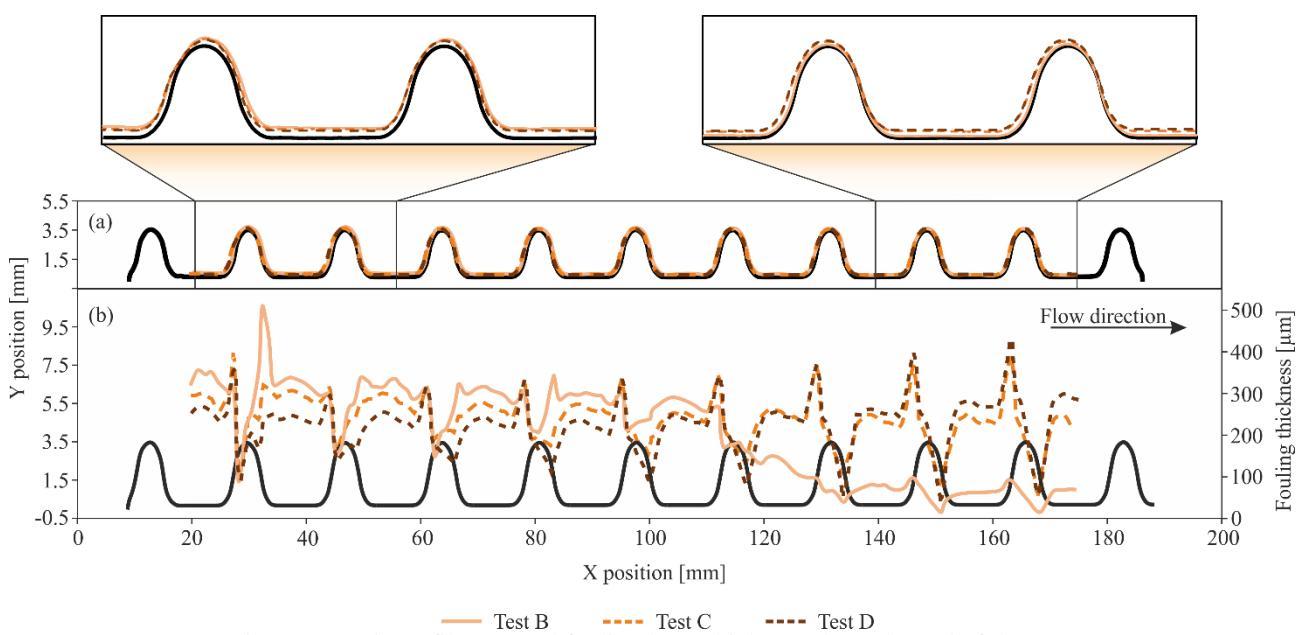
Fig. 8. Deposit profiles (a) and fouling layer thickness (b) at the end of the test.

Analyzing the local fouling layer thickness it has been noted a strong relationship between the fouling thickness and the coolant temperature in the first half of the plate. The test B —with the lowest coolant temperature— presents the highest average fouling layer thickness, as Table 3 reports. This effect is causes by the strong thermal gradient that appear in the inlet region of the plate and that is more pronounced in the test with the lowest coolant temperature. Thus, in accordance with previous studies [24–26], thermophoresis effect plays an important role in the particulate matter deposition giving rise to thicker deposits when the coolant temperature is lower.

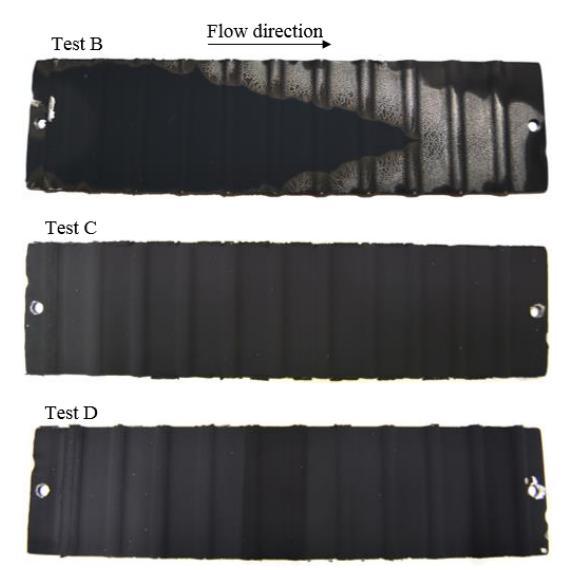
Fig. 9. Final appearance of fouling deposit of tests B, C and D.

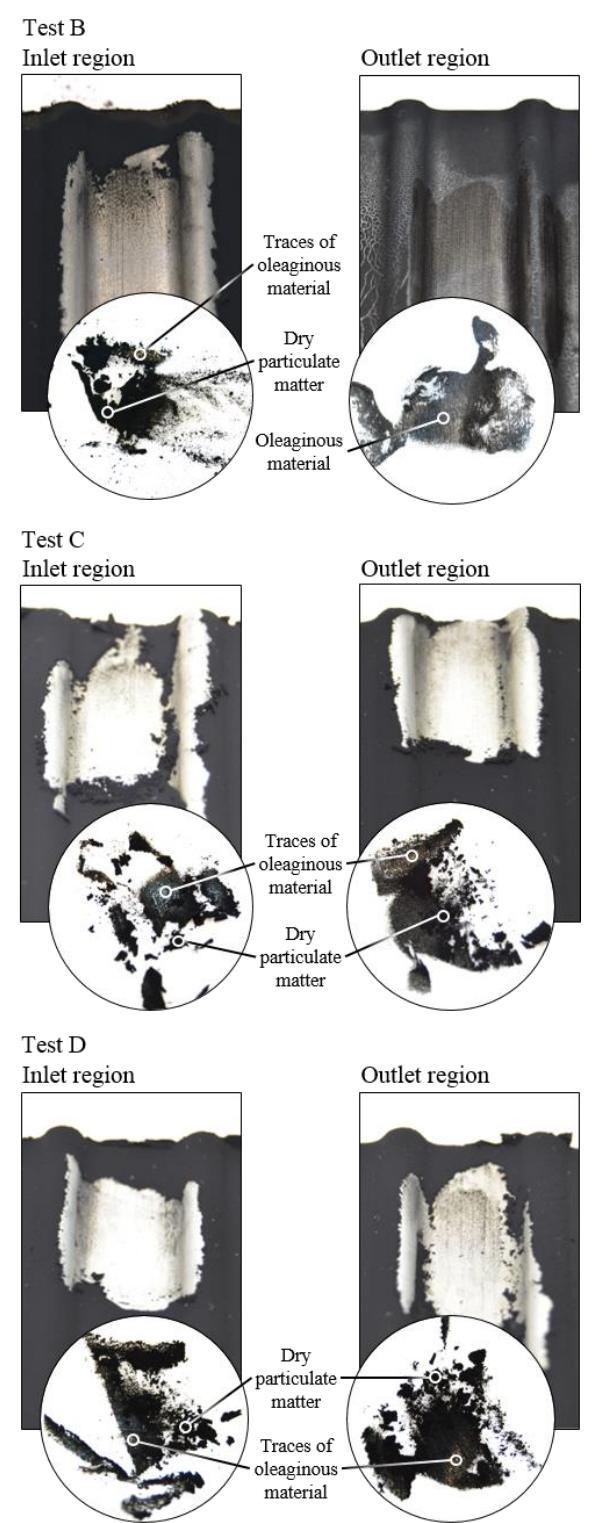
Scratching the fouled deposits allows to detect that the fouling layer of test B is an oleaginous deposit, especially in the

outlet region, as Figure 10 shows. In the outlet region —where condensation is more persistent— deposit becomes "wet" and its appearance becomes lacquer-like [20]. Deposits of tests C and D, both at the inlet region and at the outlet region, show brittle appearance and, although they are mainly made up of dry fluffy soot particles, trace amounts of oleaginous material have also been found.

Fig. 10. Scratched of the fouling deposit of tests B, C and D.
