FOULING-REPELLENT COATING FOR SHELL-AND-TUBE HEAT EXCHANGERS

C. Bischoff¹, T. Poulsen¹, R. Losada¹, J.O. Mortensen¹, L. Jackowski² and S.T. Taylor²

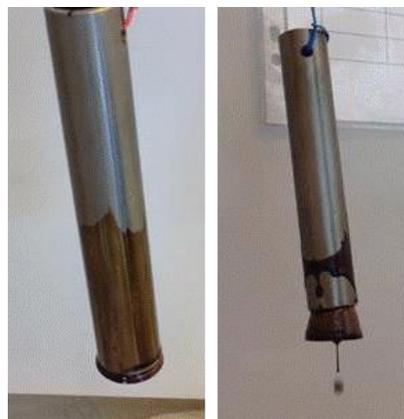
Figure 1: Following extraction from the crude oil:water test media, the liquids drain immediately from the coated tubes (right). The liquids remain on an uncoated tube section.

Figure 1 depicts a coated CS tube immediately after extraction from the 1:1 crude oil:water test media. The oleophobic/hydrophobic properties are intact, as evident by the immediate drainage of liquids from the coated metal surface.
